## County Residents Partner with FEMA to Secure Waterway

### Full Mitigation Best Practice Story

#### *Oakland County, Michigan*

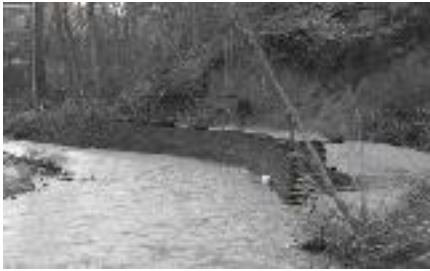
Bloomfield Area During Construction.

As a community committed to the protection of its natural features, this project focused on the use of innovative engineering alternatives that included brush mattresses, live staking, fascines, pools and riffles, and vegetated geocell retaining walls. The 100-year floodplain elevation was not increased at any of the project sites. In addition, this project included an extensive reforestation phase. Among all four sites, a total of 911 new trees were planted which included American Sycamore, Silver Maple, Red Maple, Sugar Maple, River Birch, and White Pine.

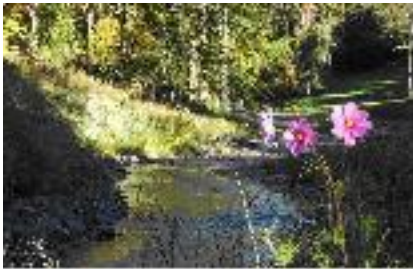
Bloomfield Area Post Project

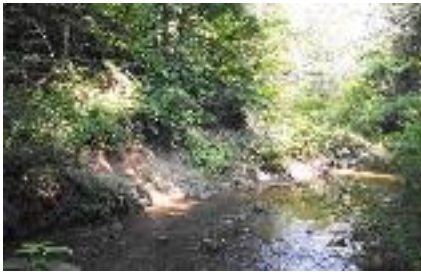
Bloomfield Area Pre Project
